PROPERTY CONDITION ASSESSMENT
220 LONDON ROAD, BALDERTON.
NEWARK AND SHERWOOD DISTRICT COUNCIL

FRIDAY 11TH NOVEMBER 2022

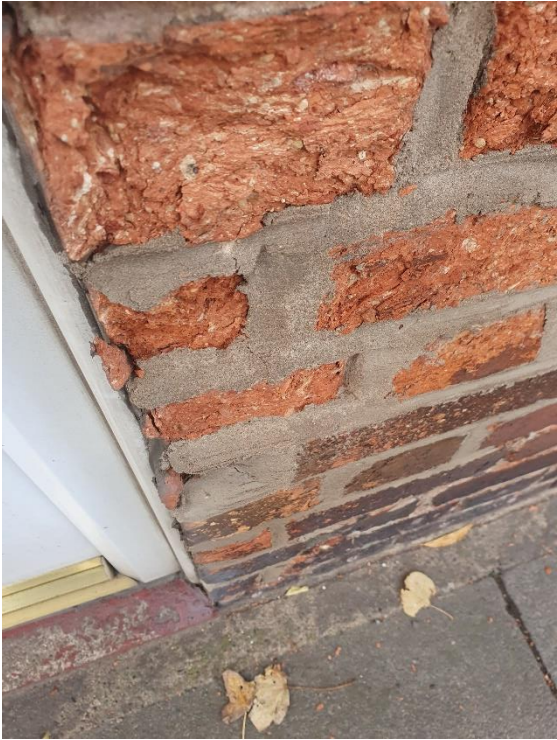
- 2.1.5 Various repairs have been undertaken to the brickwork including brick replacements and re-pointing.
- 2.1.6 There are signs the property has been treated for damp on various occasions by a chemically injected DPC to both brickwork and mortar.

Repairs to front elevation

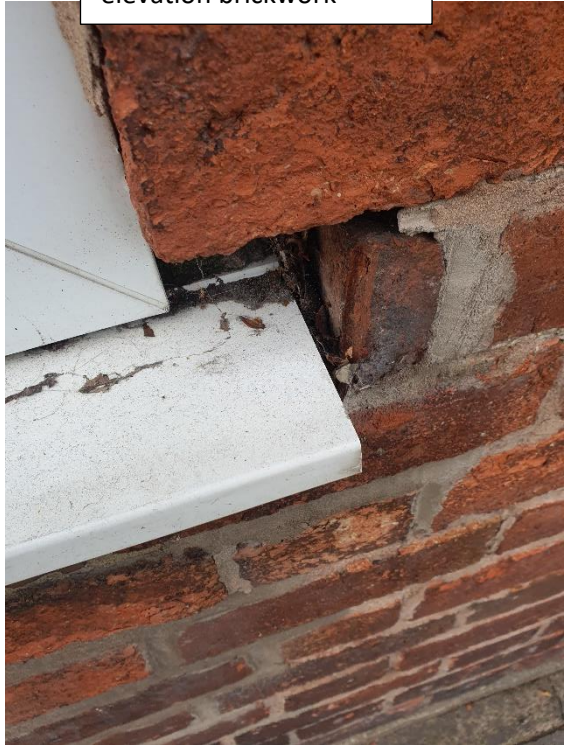
- 2.1.4 The brickwork to the ground floor areas front, side and rear are in poor condition. Bricks are spalling due to the high moisture content and frost damage.

Repairs required to front elevation brickwork

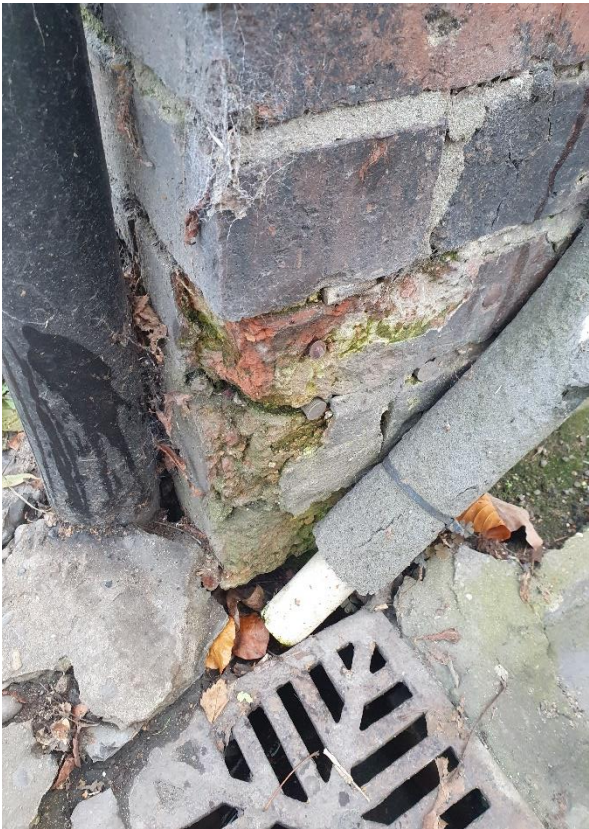
- 2.2.9 There are signs of damp on the internal wall that separates lounge and kitchen.
- 2.2.10 The dining room is to the front of the property. The resident mentioned that the room floods when there is heavy rain, and the drains are blocked externally.

Front corner of property where water enters dining room

Externally the problem with the road runoff and the drainage system is an issue. This will need to be cured to prevent the dining room from becoming flood on occasion. The gable end wall would benefit from EWI, as the brickwork is particularly poor in this area and would help the thermal properties of the house due to the large expanse of 9" brickwork.

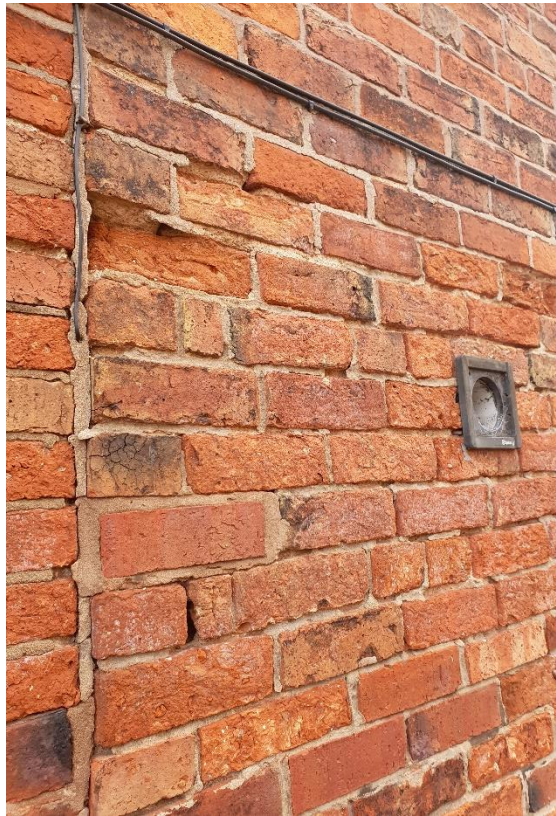
Side elevation brickwork

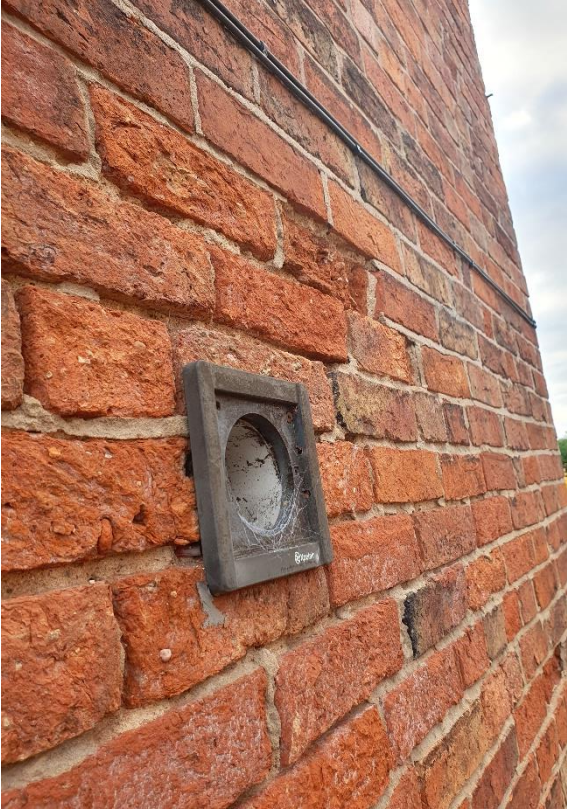
Missing vent cover and spalling brickwork to side elevation

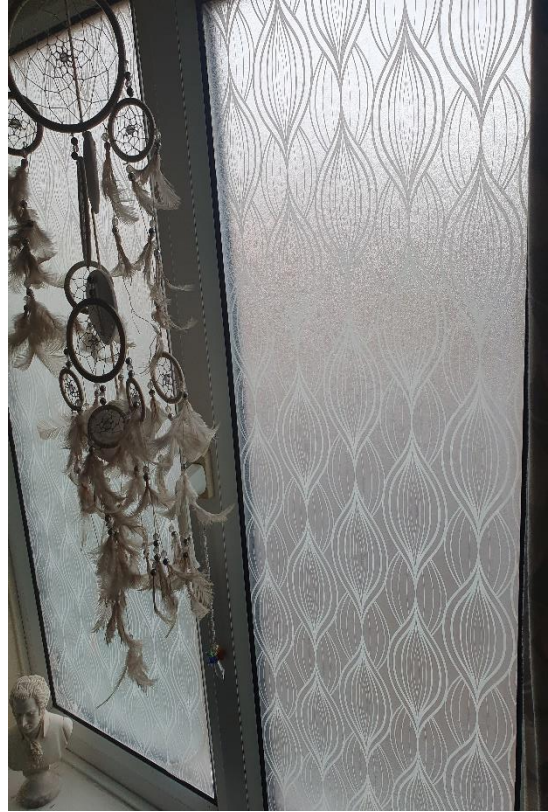
- 2.2.4 The window in the lounge is below standard having no trickle vents and the opening casement opening into the room.
- 2.2.5 The lounge floor is of solid construction (concrete or pitch mastic) and is uneven, but due to floor coverings at the time of survey I was unable to determine the cause

Internally opening window with no trickle

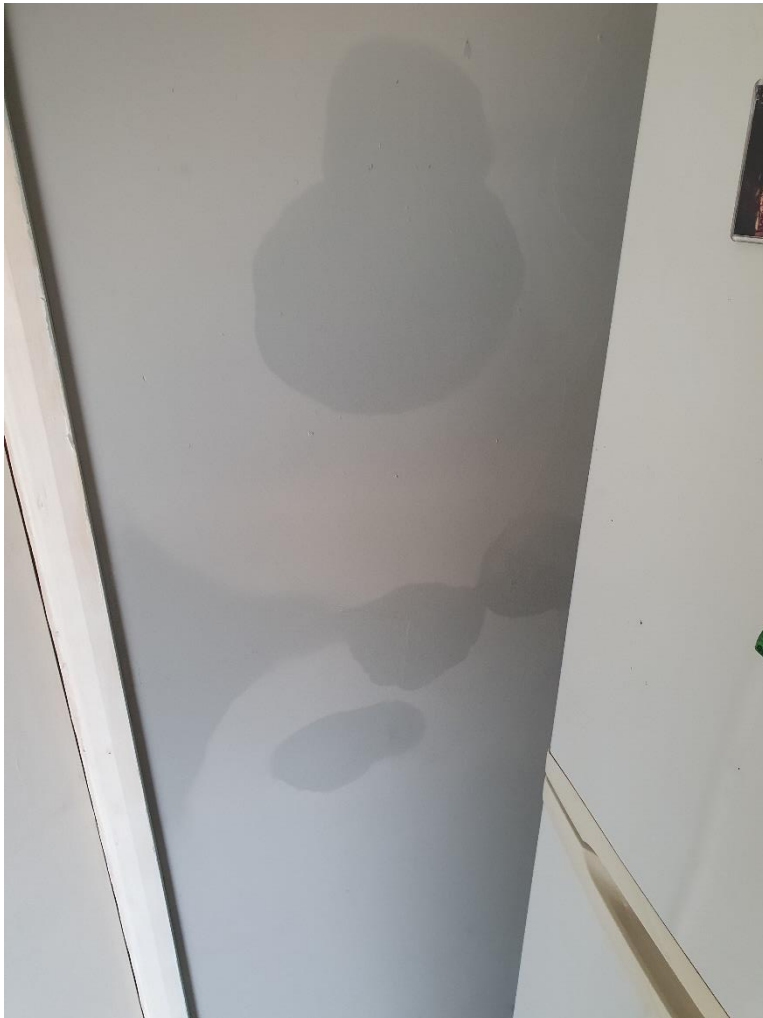
Signs of damp on internal wall between lounge and kitchen

Internally this property would benefit from a programme of works to renew the kitchen and bathroom, but it is evident that there are major issues with damp due to the lack of DPM, so this would need to be remedied before these works were undertaken.

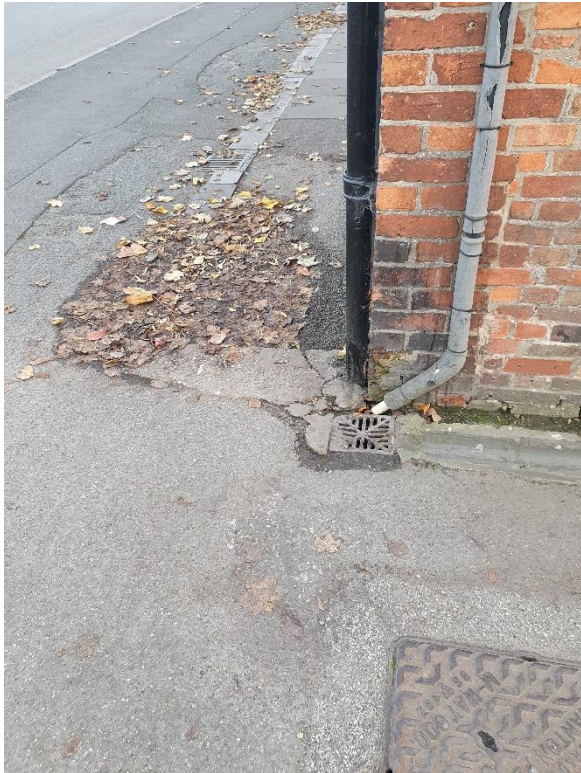
Corner of property where water enters

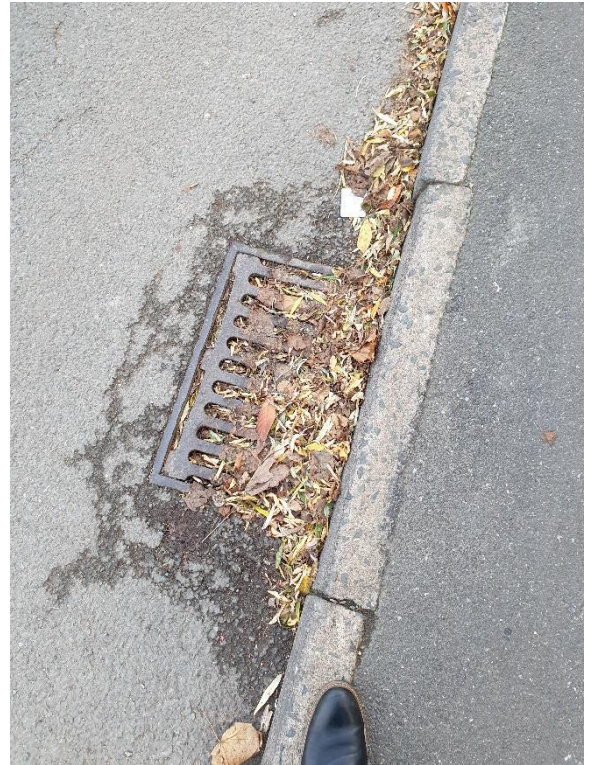
- 2.1.2 The property is adjacent to a busy main road which is higher than the property and there is a pavement that separates them.
- 2.1.3 At the time of inspection, the main drain to the road was block with leaves and debris, and the gulley at the corner of the property was starting to get blocked up with leaves

Blocked main drain on road

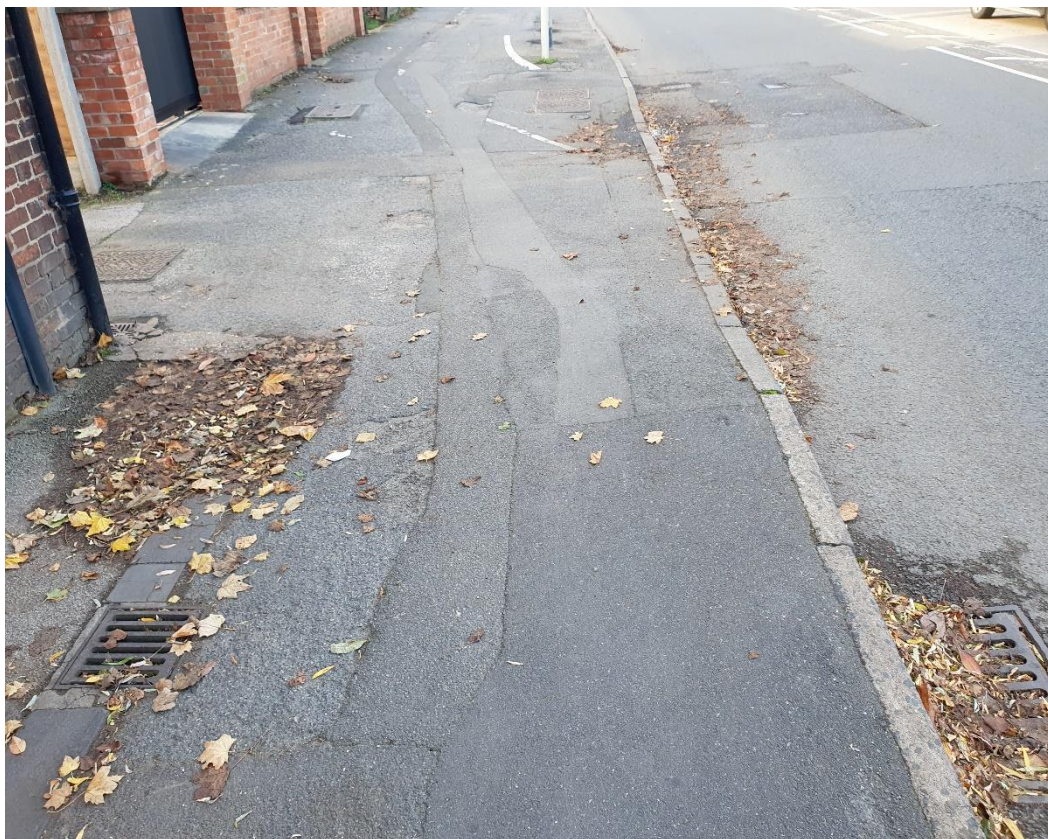
Photo of road runoff area
