**PROPERTY CONDITION ASSESSMENT
224 LONDON ROAD, BALDERTON.
NEWARK AND SHERWOOD DISTRICT COUNCIL**

FRIDAY 11TH NOVEMBER 2022

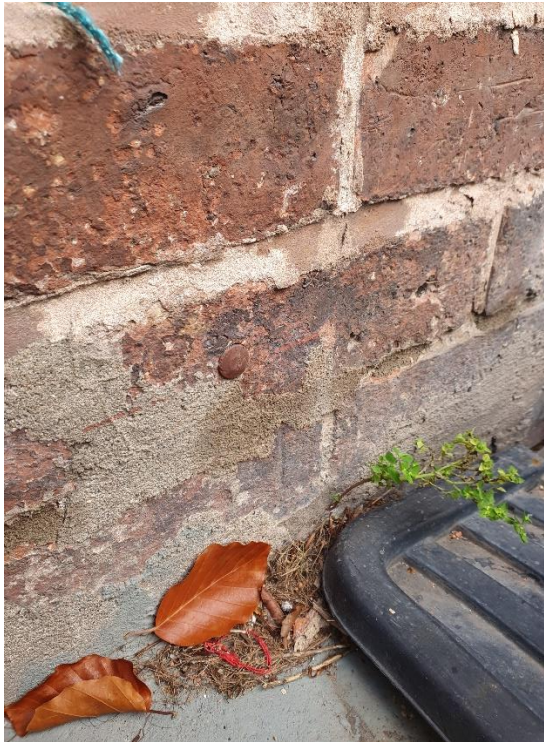
- 2.1.4 Various repairs have been undertaken to the brickwork including brick replacements and re-pointing.
- 2.1.5 There are signs the property has been treated for damp on various occasions by a chemically injected DPC to both brickwork and mortar.

Evidence of historic DPC

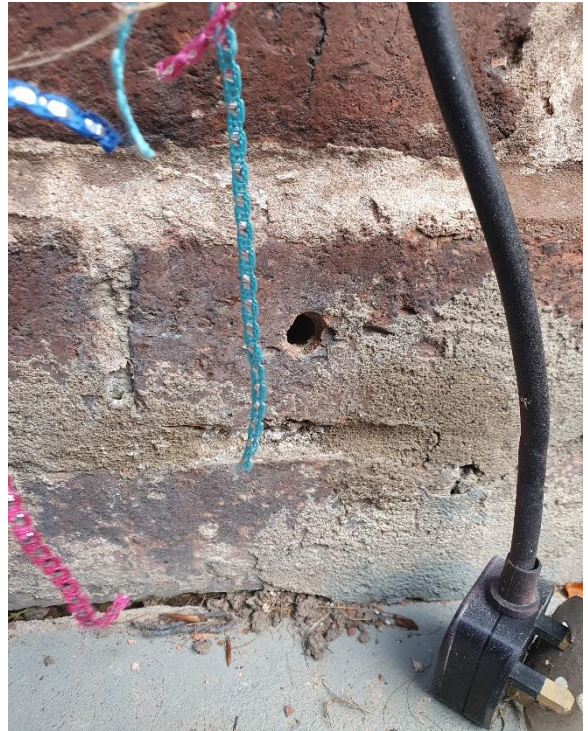
DPC to brickwork and mortar

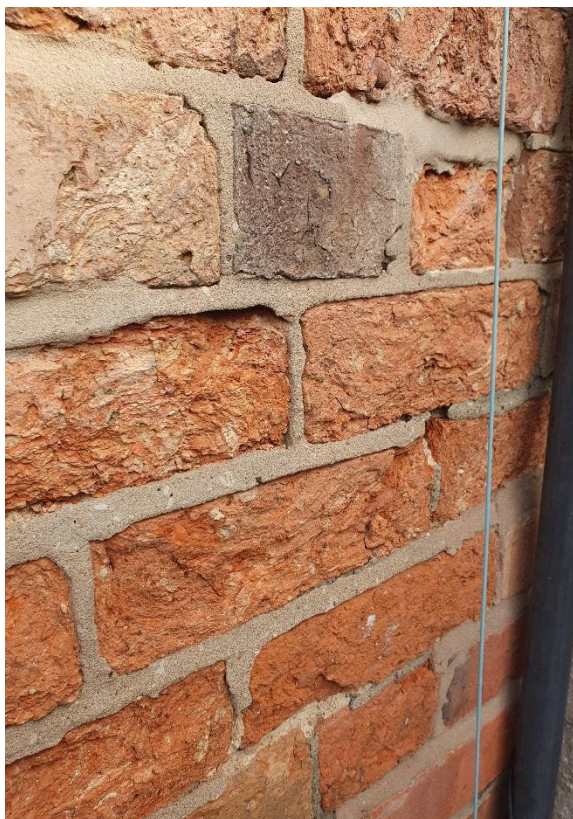
- 2.1.2 The property is adjacent to a busy main road which is higher than the property and there is a pavement that separates them.
- 2.1.3 The brickwork to the ground floor areas front and rear are in poor condition. Bricks are spalling due to the high moisture content and frost damage.

From the inspection and a conversation with the resident, there seems to be a high-water table in this area. The resident mentioned that the garden often floods during heavy rain and that with the main road to the front of the property being higher than the property, means the properties in the terrace often have issues with water runoff from the road. This seems to be evident in the brickwork as high moisture content is spalling large areas of the bricks.

Spalling brickwork rear elevation

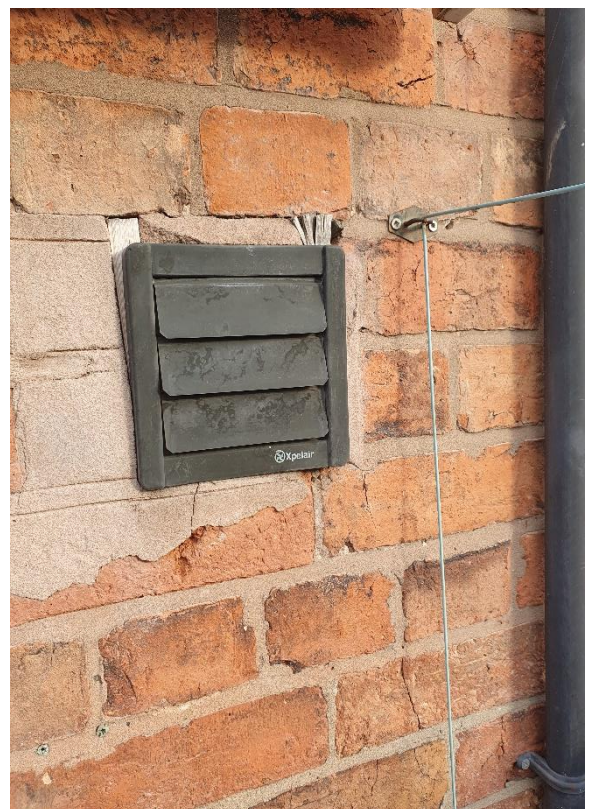
Poor repair work after extractor installation

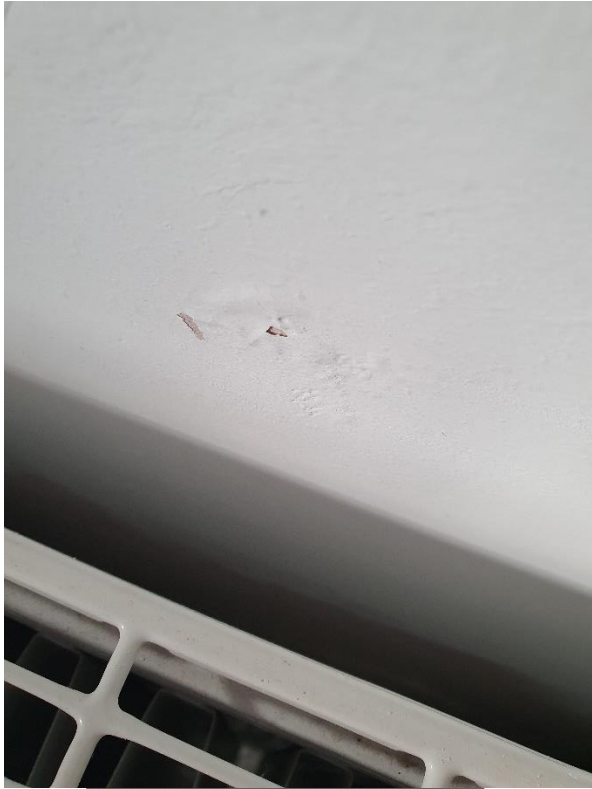
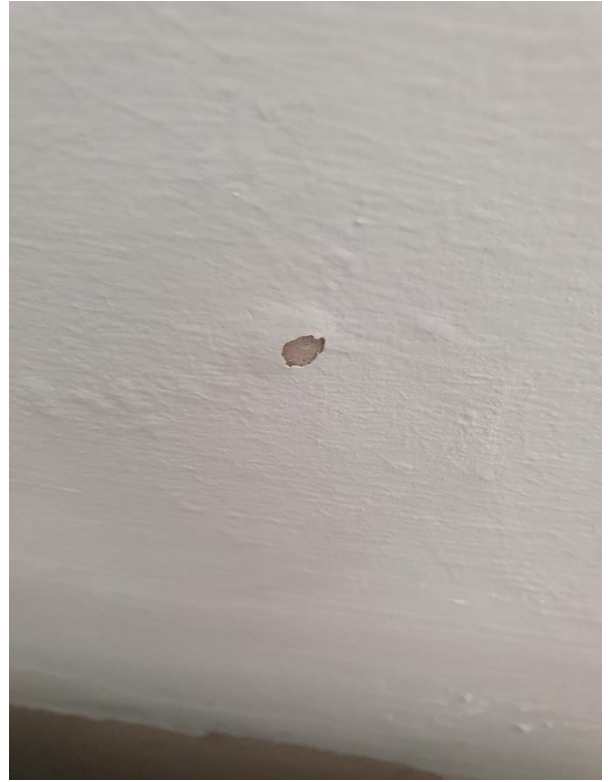
- 2.2.5 The kitchen at the rear of the property off the lounge.
- 2.2.6 There are signs of damp on the chimney breast and some other areas of paintwork are starting to peel away from the plasterwork.

Peeling paintwork in kitchen

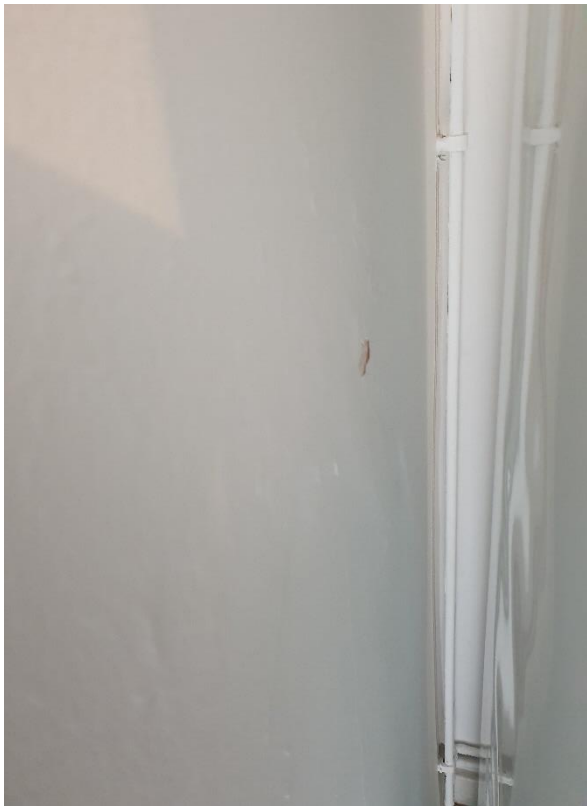
Peeling paintwork to external wall kitchen

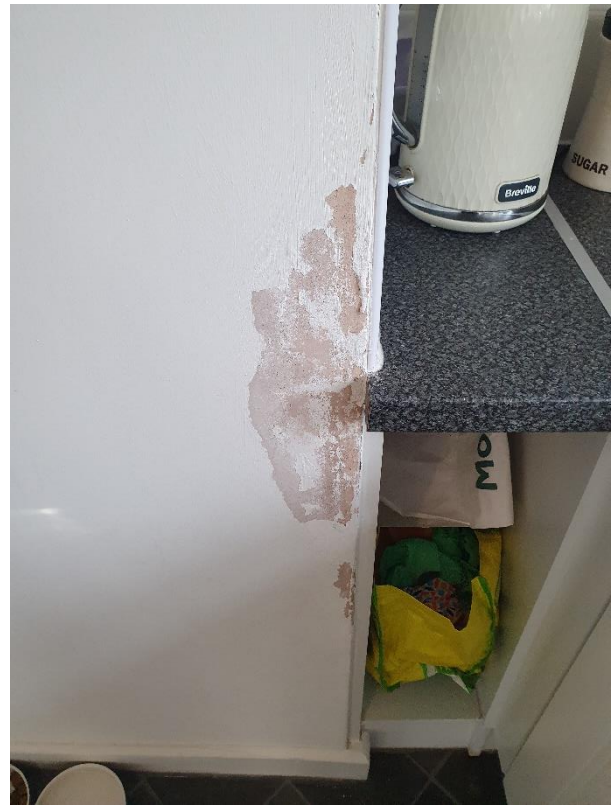
Internally this property is well maintained by the resident, but it is evident that there are major issues with damp due to the lack of DPM and there may also be ongoing issues with the rear chimney, further intrusive investigation would need to be done to determine this.

Damp to chimney breast in kitchen, previous works to chimney and DPC have been done

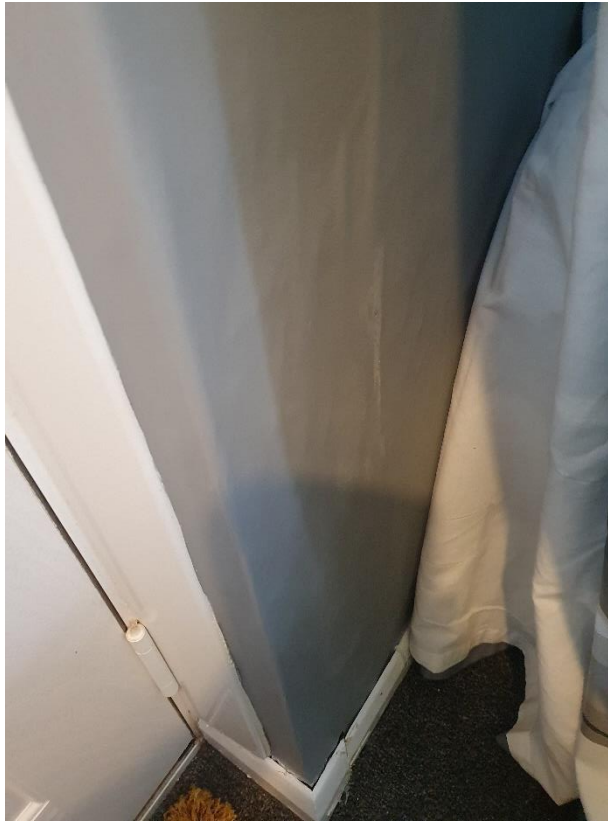
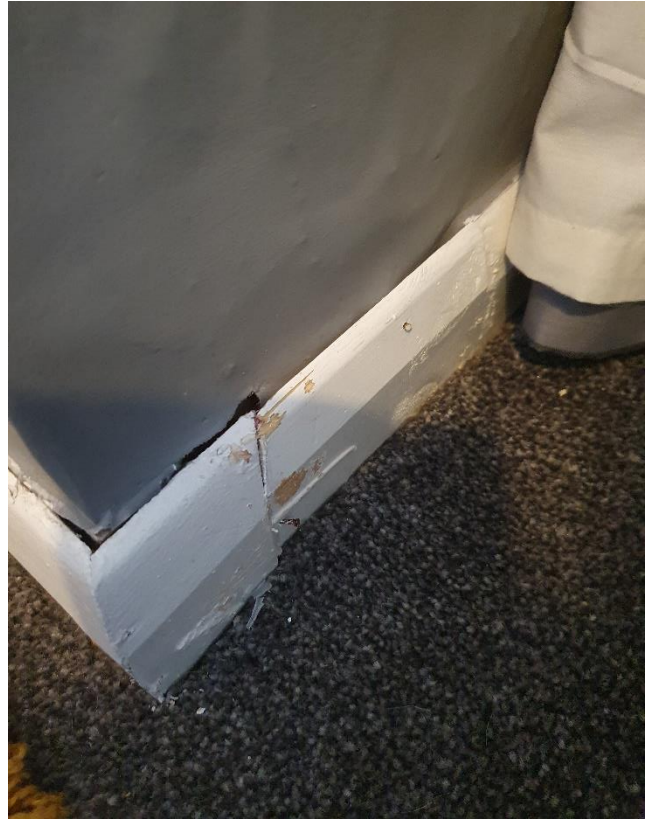
- 2.2.1 The lounge is at the front of the property with the front door straight from the pavement into the room.
- 2.2.2 The lounge is in a good state of decoration other than signs of damp adjacent to the right of the front door.
- 2.2.3 The window in the lounge is below standard having no trickle vents and the opening casement opening into the room.

Damp to wall right of front door in lounge

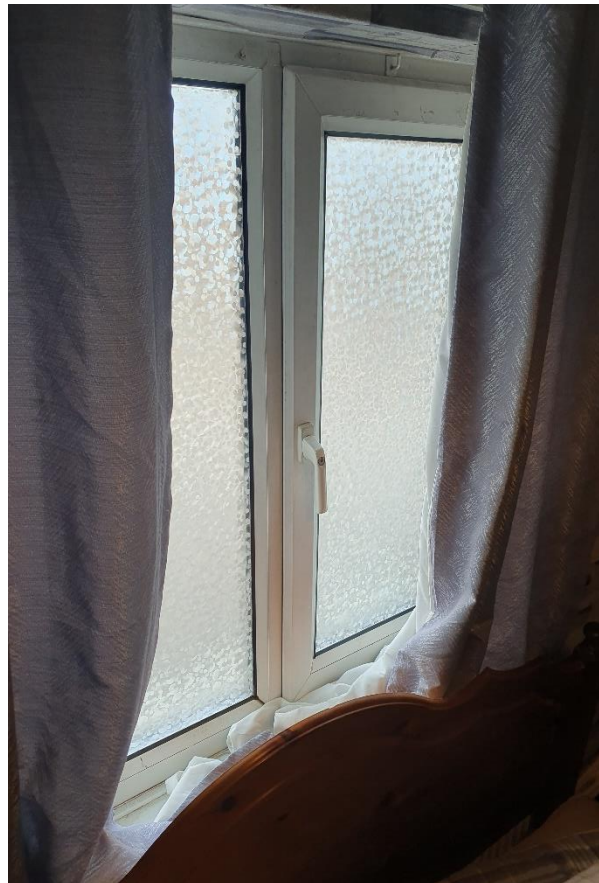
- 2.2.14 There are bedrooms to the front and rear, both in a good state of decoration.
- 2.2.15 Windows are required to both bedrooms, as these are substandard without trickle vents and inward opening casements. There are also signs of condensation mould around the window reveals.

Opening inwards windows with no trickle vents

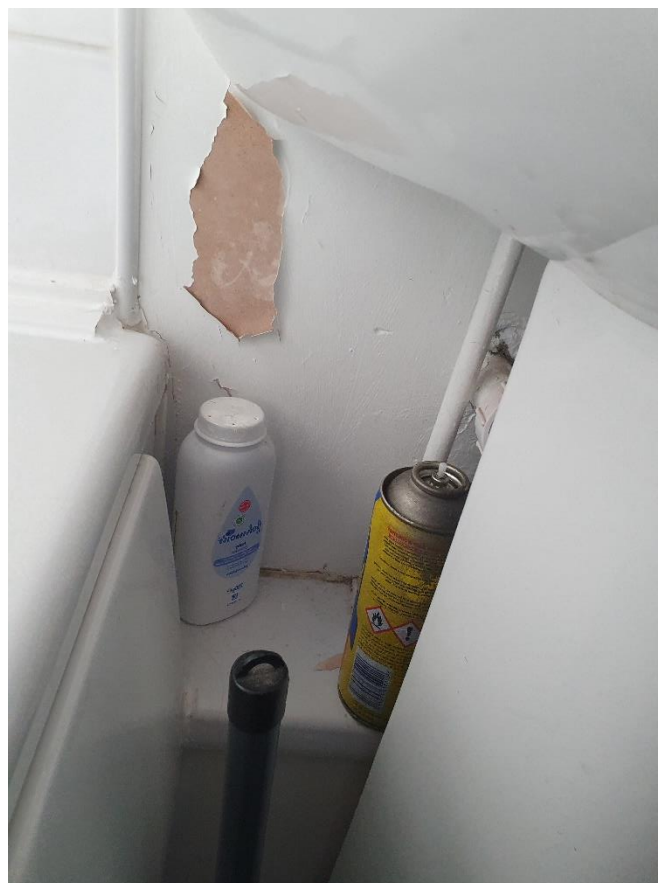
- 2.2.12 The bathroom has been renewed and is in good condition.
- 2.2.13 There is a sign of damp to the wall under the wash hand basin in the bathroom, this looks to be caused by condensation and there are no signs of any leaks.

Damp area in bathroom possible condensation

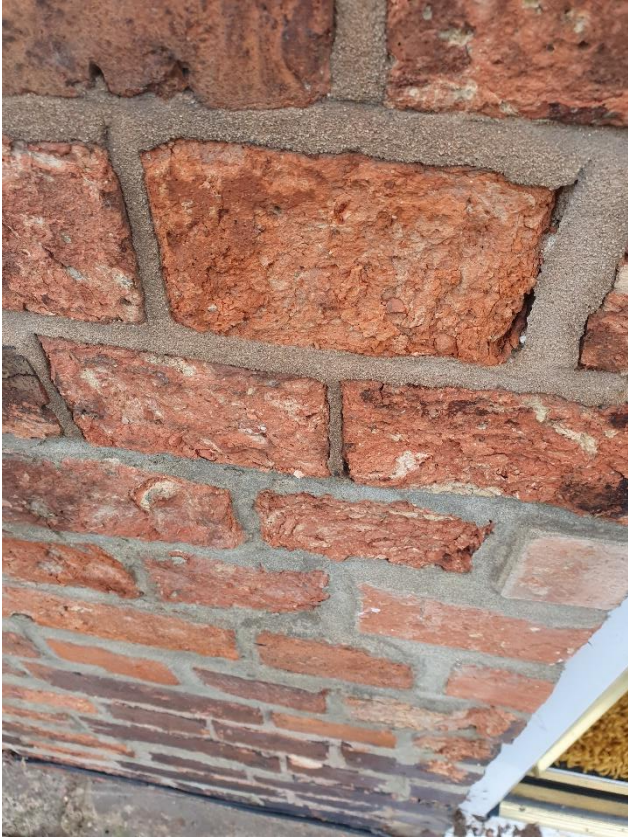
Spalling brickwork to front elevation

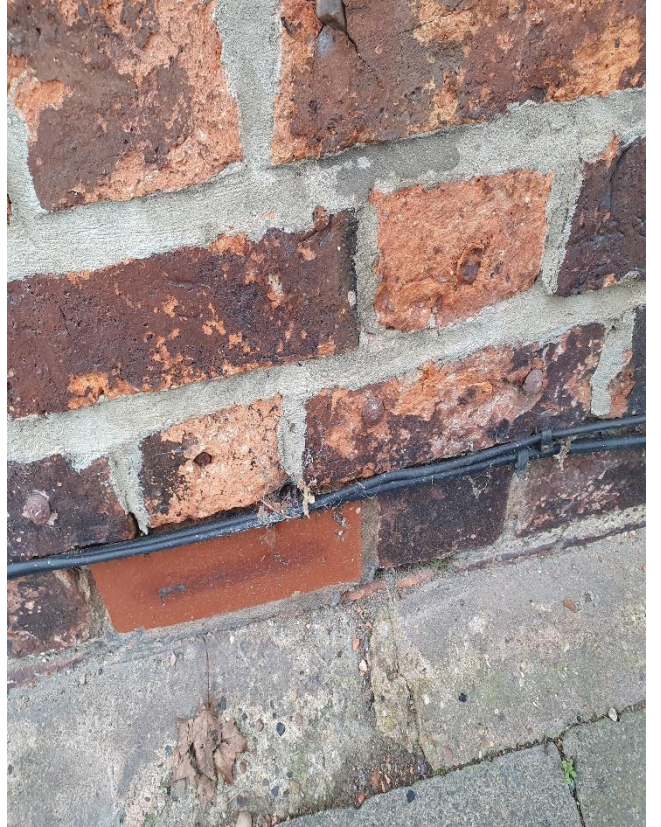
Repairs to front elevation brickwork

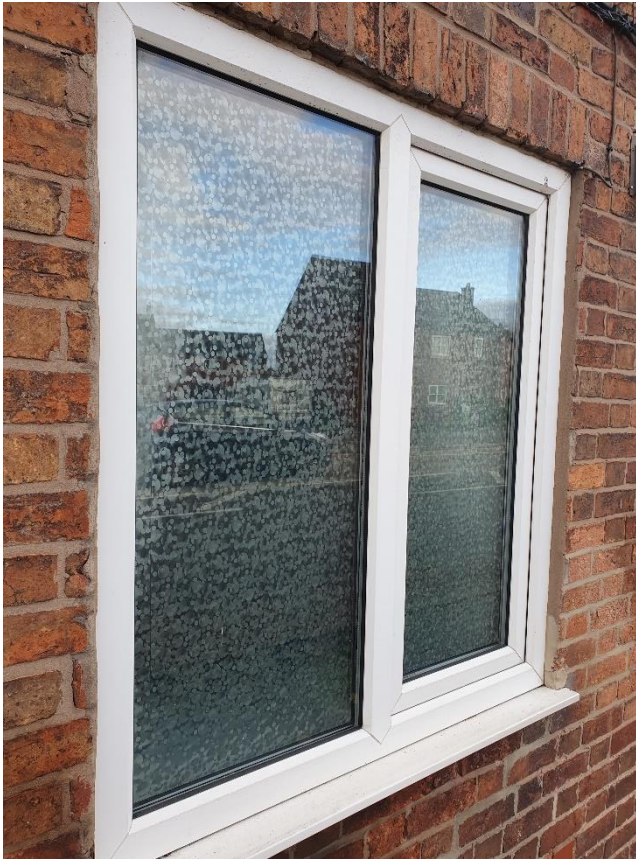
More evidence of sub-standard windows

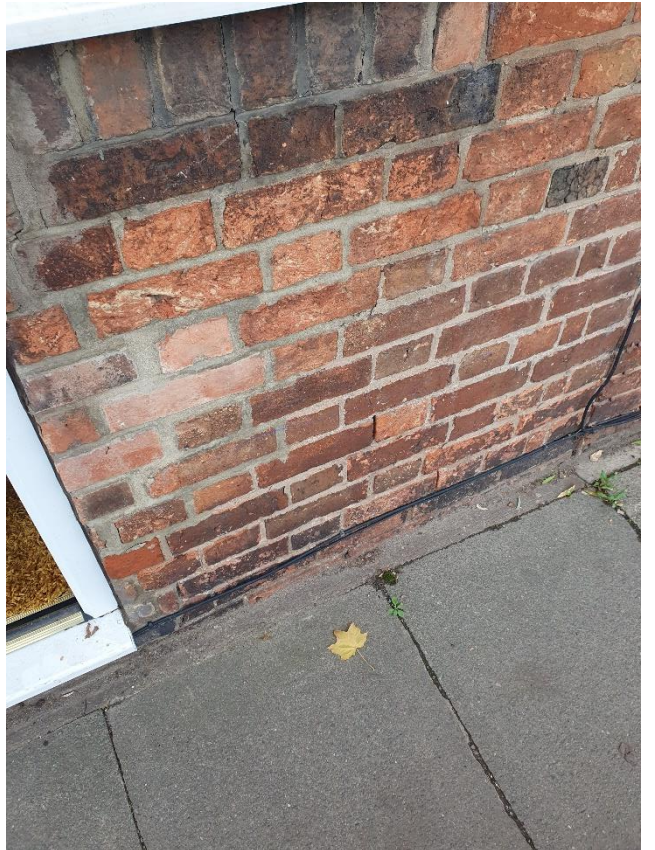
Repairs to front elevation, but more required
